PRESERVATION

Rust *Repair* Instead of *Replace*

By Arvid Svendsen

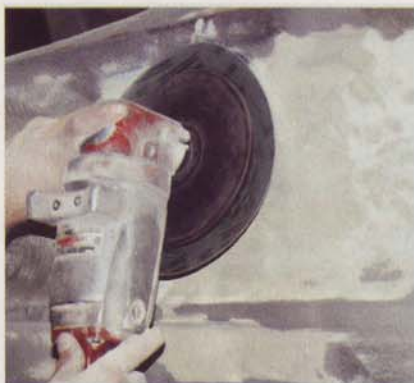
1 At first glance, the Nova's passenger-quarter's overabundance of filler suggests major dents and damage. Bill Jelinek of Rt. 66 Motorsports thought otherwise and set out to uncover the actual condition of the metal by buzzing the filler off the panel with an 8-inch grinder fitted with 3M 24-grit 9-inch discs.

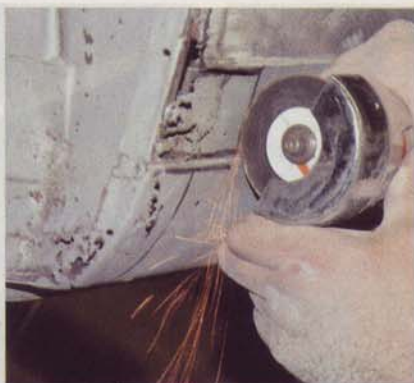
4 The 3-inch cutoff wheel went to work to remove the rusted metal.

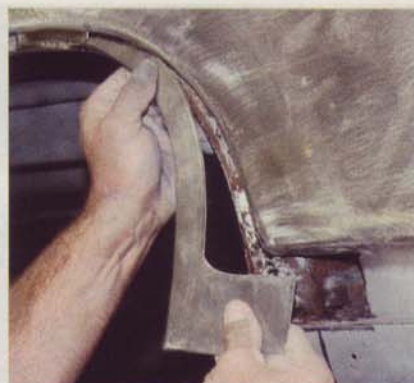
6 Jelinek checked the patch's fit before doing final trimming and deburring.

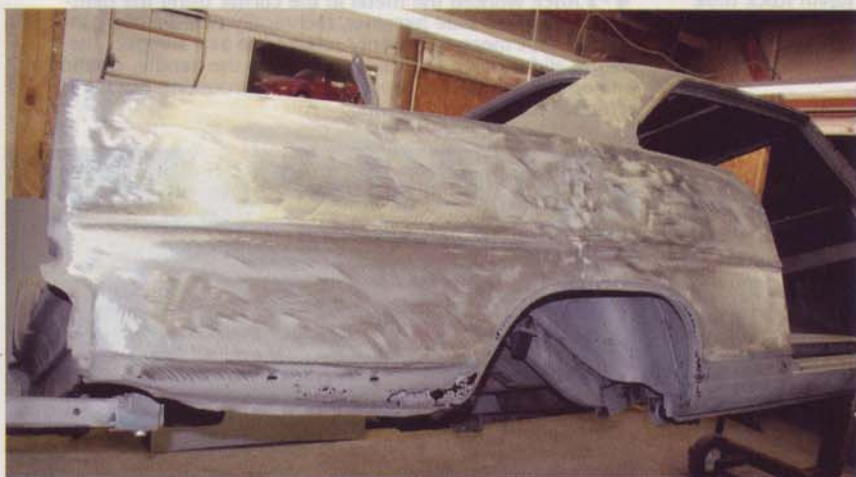
2 After the filler was removed, three trouble spots became evident: a fairly large, low area directly above the tire; a low spot near the Super Sport emblem location and a dent in the rearmost bottom corner of the quarter. The rust along the bottom of the quarter and wheelwell lip is minimal and can be easily repaired.

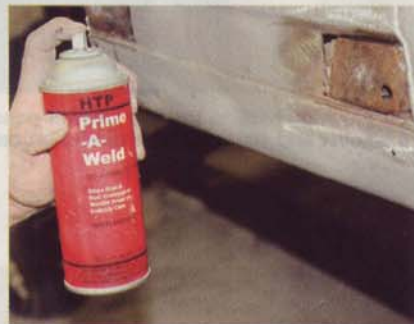
7 The panel and inner structure were ground clean before Jelinek sprayed HTP Prime-A-Weld, a weld-through primer, on the bare metal edges.

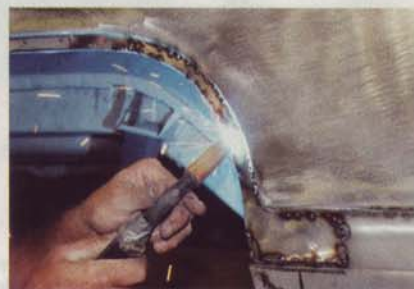
8 The rocker/wheelwell lip patch was MIG-welded to the car. It was first tack-welded to ensure proper fit, then finish-welded, with Jelinek taking care not to overheat the surrounding metal.

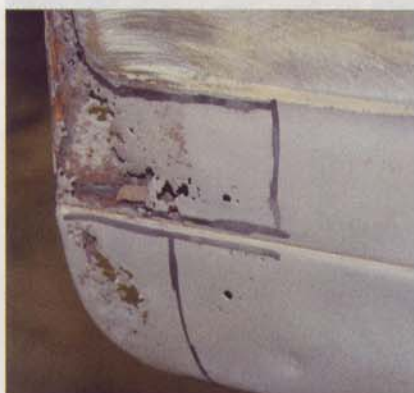
3 Cut lines are drawn on all cancerous areas. Jelinek was very conservative to remove the least amount of metal necessary.

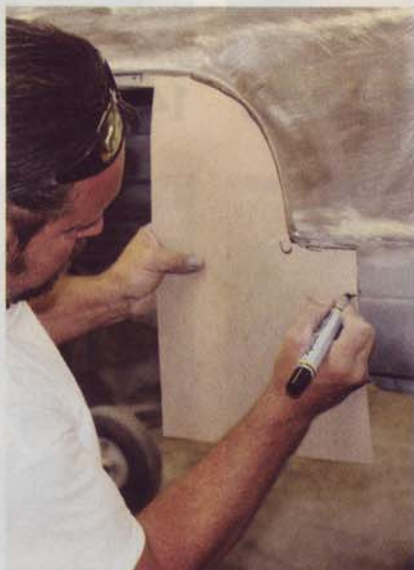
5 Using a piece of cardboard, Jelinek created a template for the sheetmetal to be replaced. Next, he traced the shape he needed and cut the patch from 18-gauge metal.

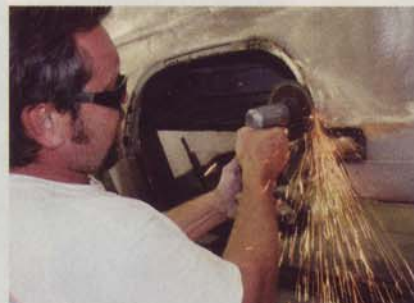
9 With the new panel in place, Jelinek used a 3M 24-grit 5-inch grinding disc to smooth the welds.

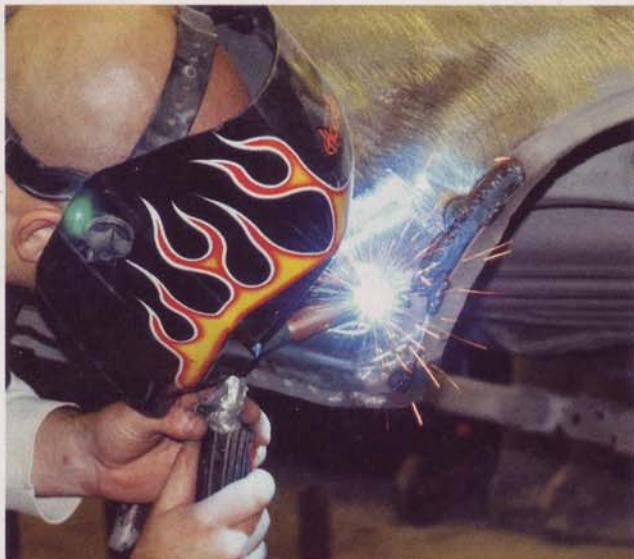
10 Moving back to the rear quarter-panel, Kevin Rock took over and continued the careful process of metal repair.

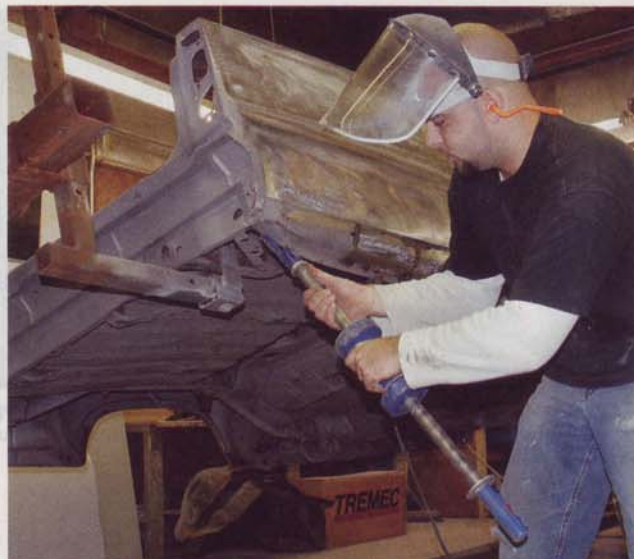
13 Rock worked the metal in the corner using the dent-removing slide hammer, technically called a Morgan Nokker, but more commonly referred to as a slugger. The weight slides down the shaft and strikes the handle, creating a pull on the panel. This process is time-consuming but very effective for removing dents.

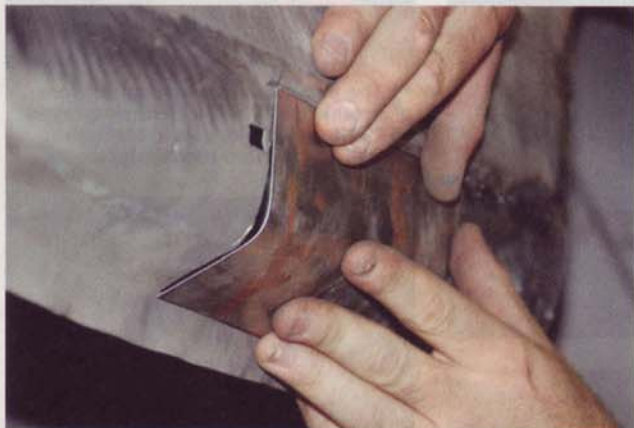
11 Rather than having one big patch, smaller patches were used in order to more accurately follow the factory shape along the bottom of the quarter-panel.

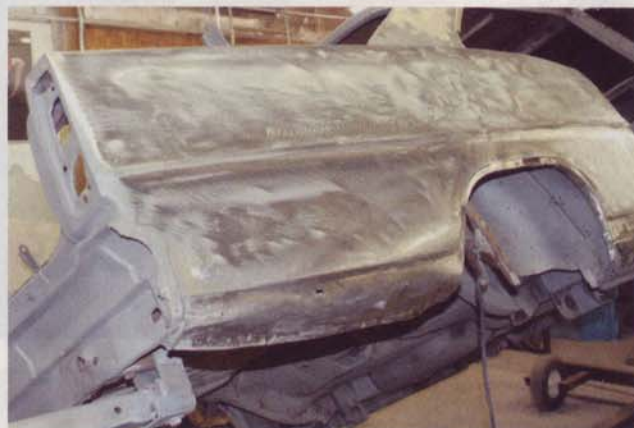
14 After Rock's efforts, the quarter-panel began to take shape, but it still needed repair on the wheel lip.

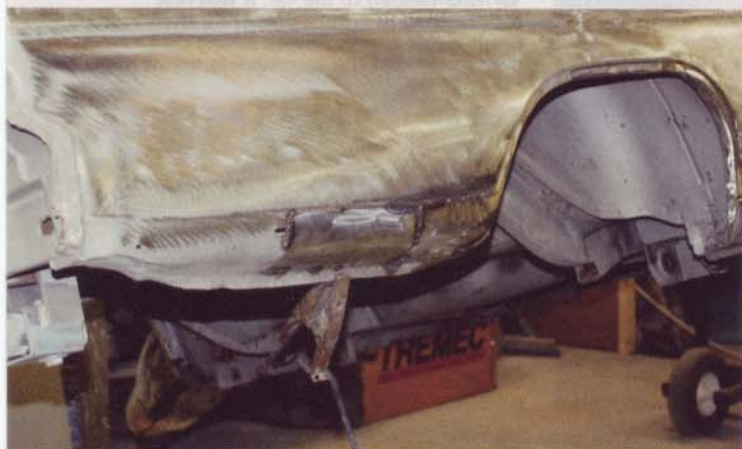
12 At this point, the dent at the rearmost bottom corner must be fixed.

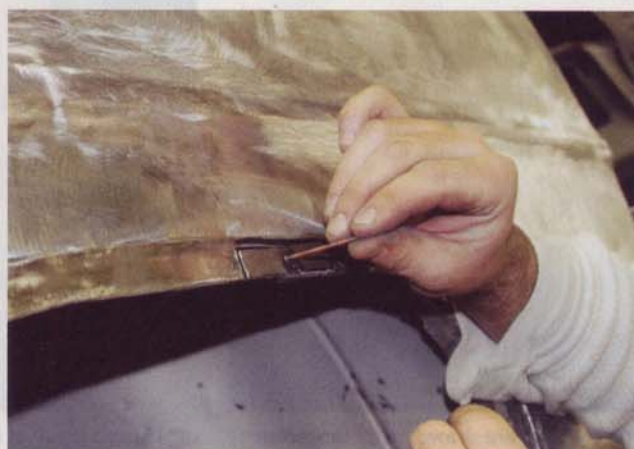
15 A small patch of metal is hard to handle, so Rock used a stud gun to attach a stud to the metal. By doing so, it can be held properly during welding.

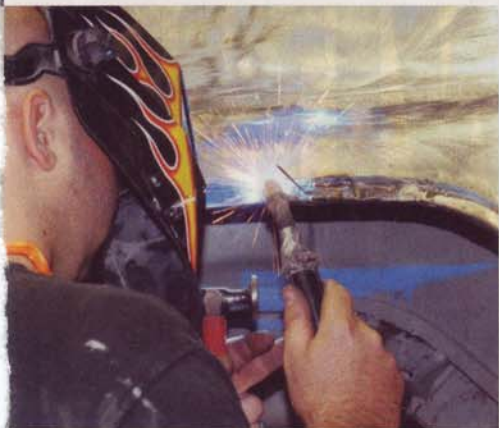
16 Rock welded the metal to the formerly cancerous portion of the wheel lip.

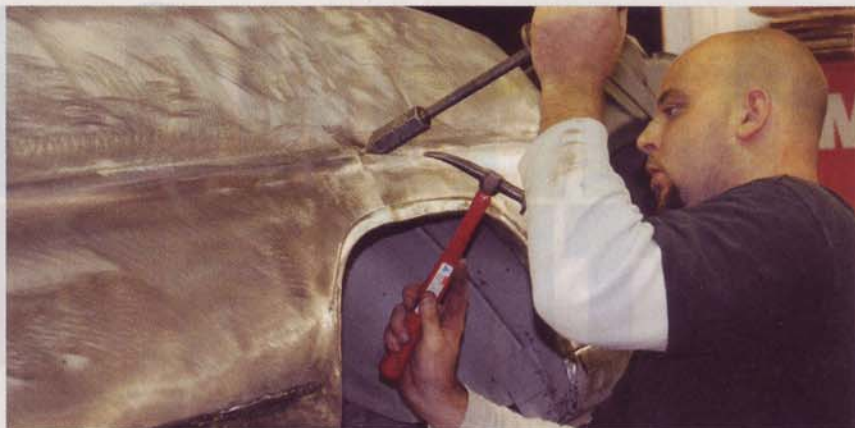
18 That stud was used as an attachment point for the Morgan Nokker. The slugger was inserted over the stud, and the metal was worked out to eliminate low area.

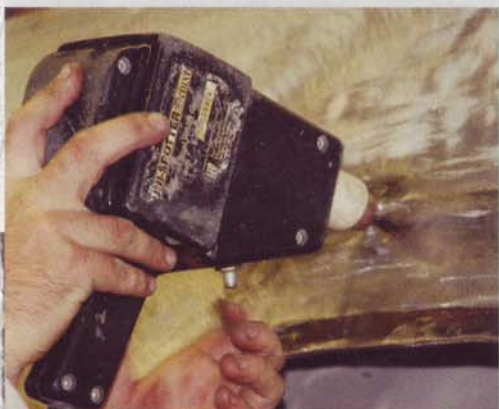
17 An H&S Uni Spotter Delux Stud Welding Gun sent a stud to the quarter at the low point.

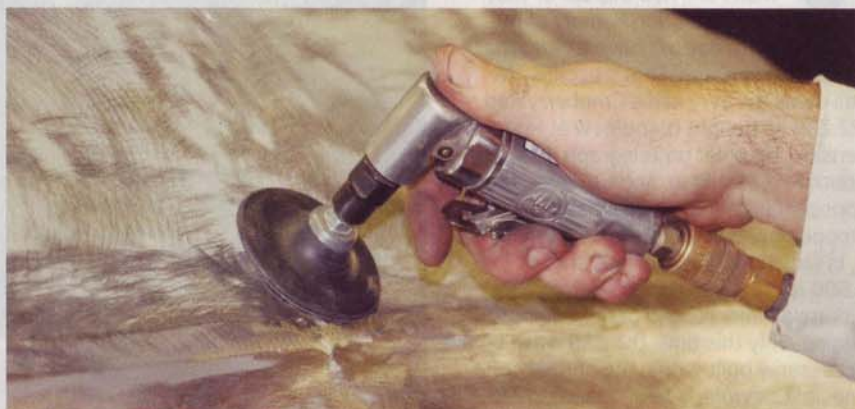
19 When the metal was where it needed to be, the stud was cut off and ground smooth. This method is far superior to drilling holes into panels in order to accomplish the same result.

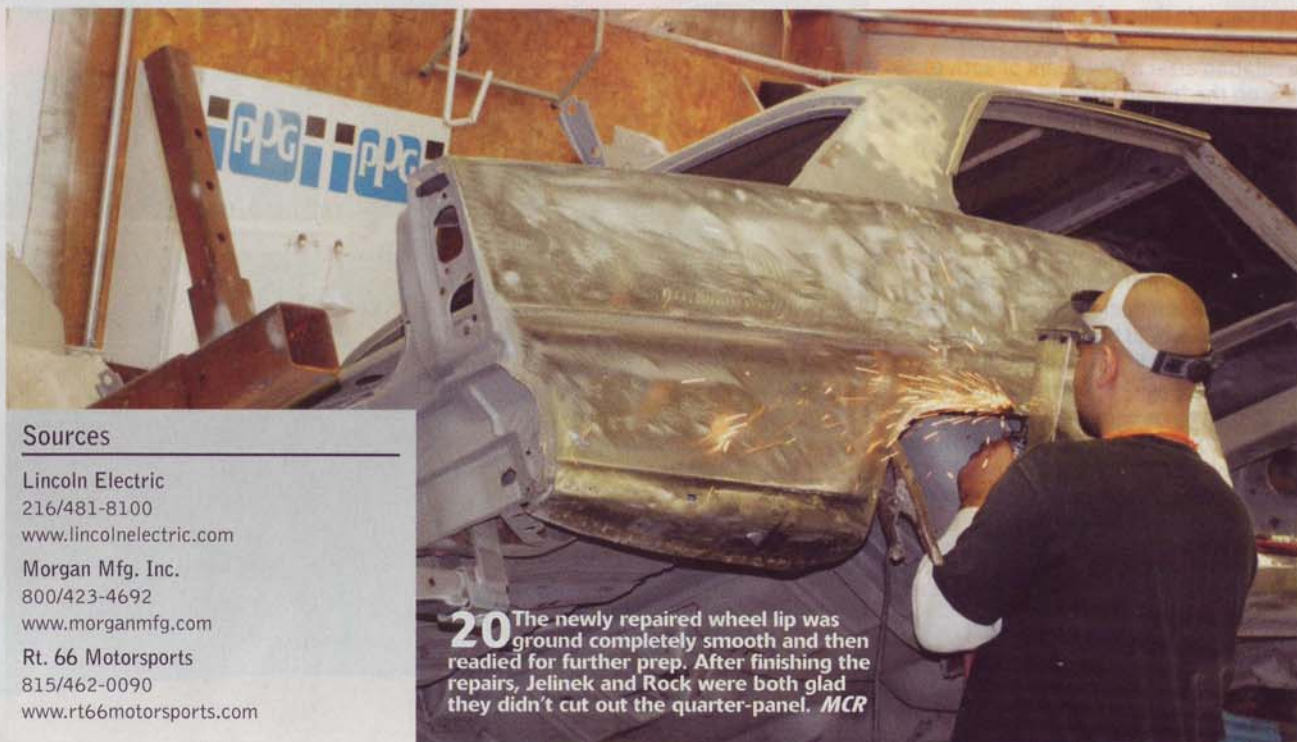
20 The newly repaired wheel lip was ground completely smooth and then readied for further prep. After finishing the repairs, Jelinek and Rock were both glad they didn't cut out the quarter-panel. *MCR*
