# PRESERVATION

## Rust *Repair* Instead of *Replace*

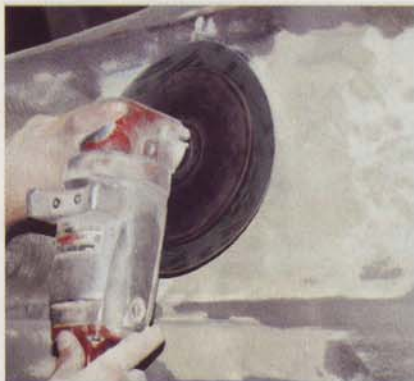
**1** At first glance, the Nova's passenger-quarter's overabundance of filler suggests major dents and damage. Bill Jelinek of Rt. 66 Motorsports thought otherwise and set out to uncover the actual condition of the metal by buzzing the filler off the panel with an 8-inch grinder fitted with 3M 24-grit 9-inch discs.

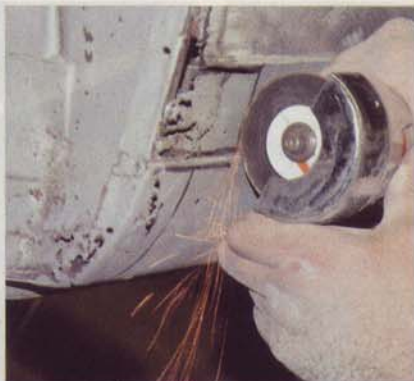
**4** The 3-inch cutoff wheel went to work to remove the rusted metal.

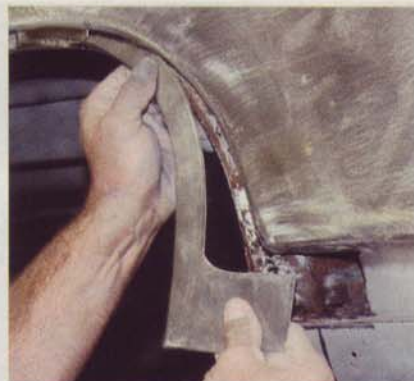
**6** Jelinek checked the patch's fit before doing final trimming and deburring.

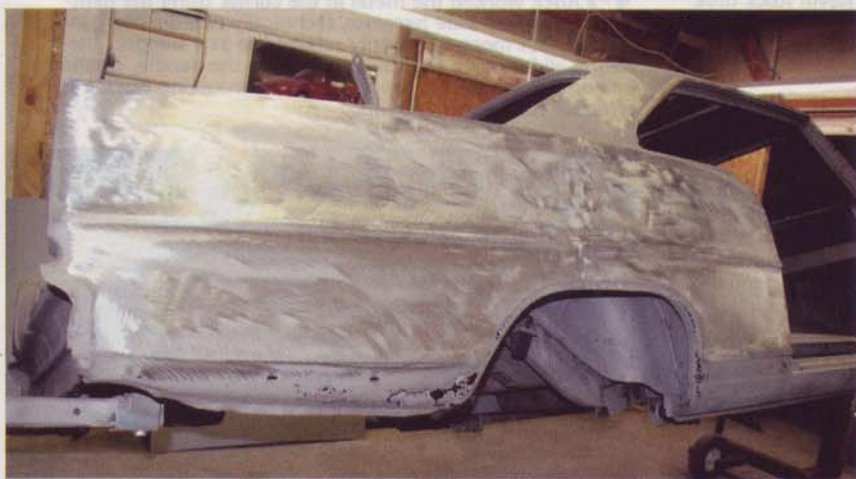
**2** After the filler was removed, three trouble spots became evident: a fairly large, low area directly above the tire; a low spot near the Super Sport emblem location and a dent in the rearmost bottom corner of the quarter. The rust along the bottom of the quarter and wheelwell lip is minimal and can be easily repaired.

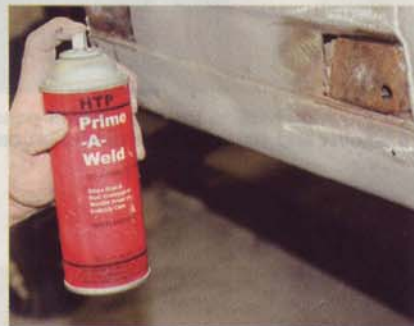
**7** The panel and inner structure were ground clean before Jelinek sprayed HTP Prime-A-Weld, a weld-through primer, on the bare metal edges.

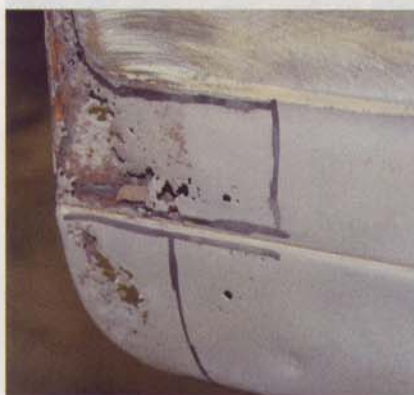
**3** Cut lines are drawn on all cancerous areas. Jelinek was very conservative to remove the least amount of metal necessary.

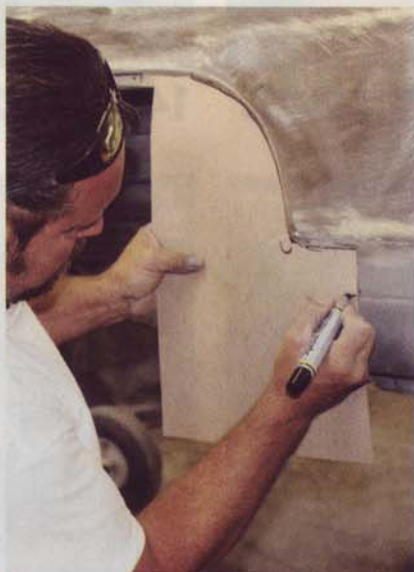
**5** Using a piece of cardboard, Jelinek created a template for the sheetmetal to be replaced. Next, he traced the shape he needed and cut the patch from 18-gauge metal.

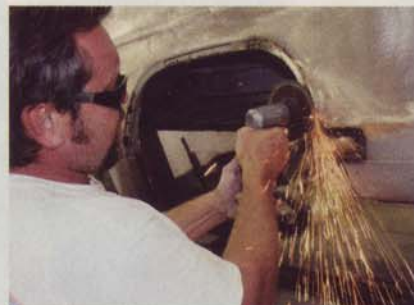
**9** With the new panel in place, Jelinek used a 3M 24-grit 5-inch grinding disc to smooth the welds.

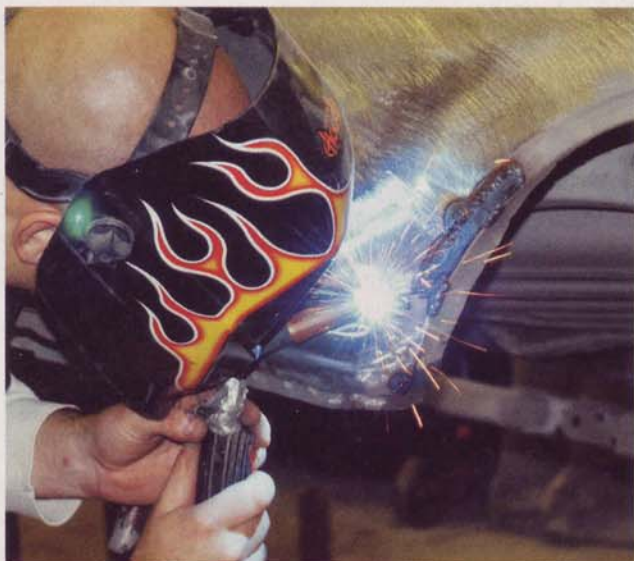
**10** Moving back to the rear quarter-panel, Kevin Rock took over and continued the careful process of metal repair.

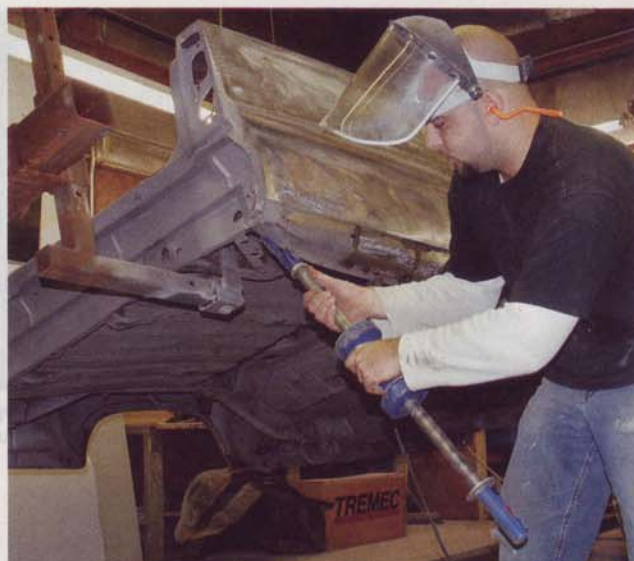
**13** Rock worked the metal in the corner using the dent-removing slide hammer, technically called a Morgan Nokker, but more commonly referred to as a slugger. The weight slides down the shaft and strikes the handle, creating a pull on the panel. This process is time-consuming but very effective for removing dents.

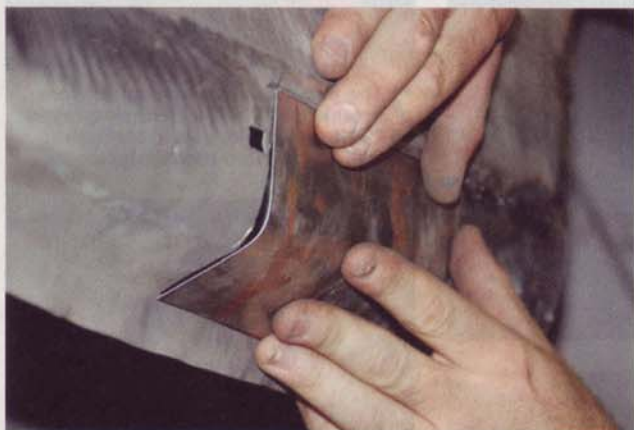
**11** Rather than having one big patch, smaller patches were used in order to more accurately follow the factory shape along the bottom of the quarter-panel.

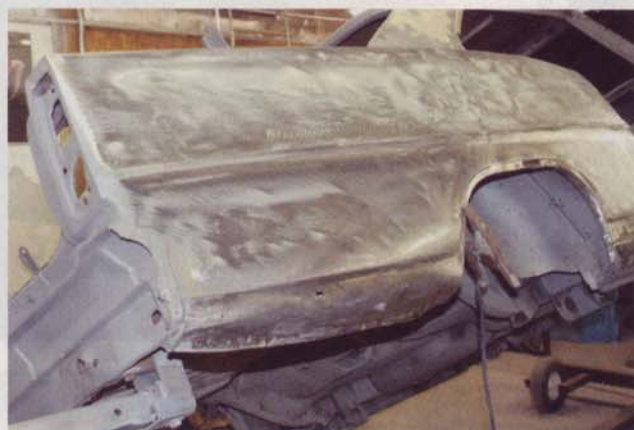
**14** After Rock's efforts, the quarter-panel began to take shape, but it still needed repair on the wheel lip.
